TS-PIC-93810  
February 1993

# AERIAL PHOTOGRAPHIC ANALYSIS OF THE NASA JET PROPULSION LABORATORY Pasadena, California

EPA Region 9

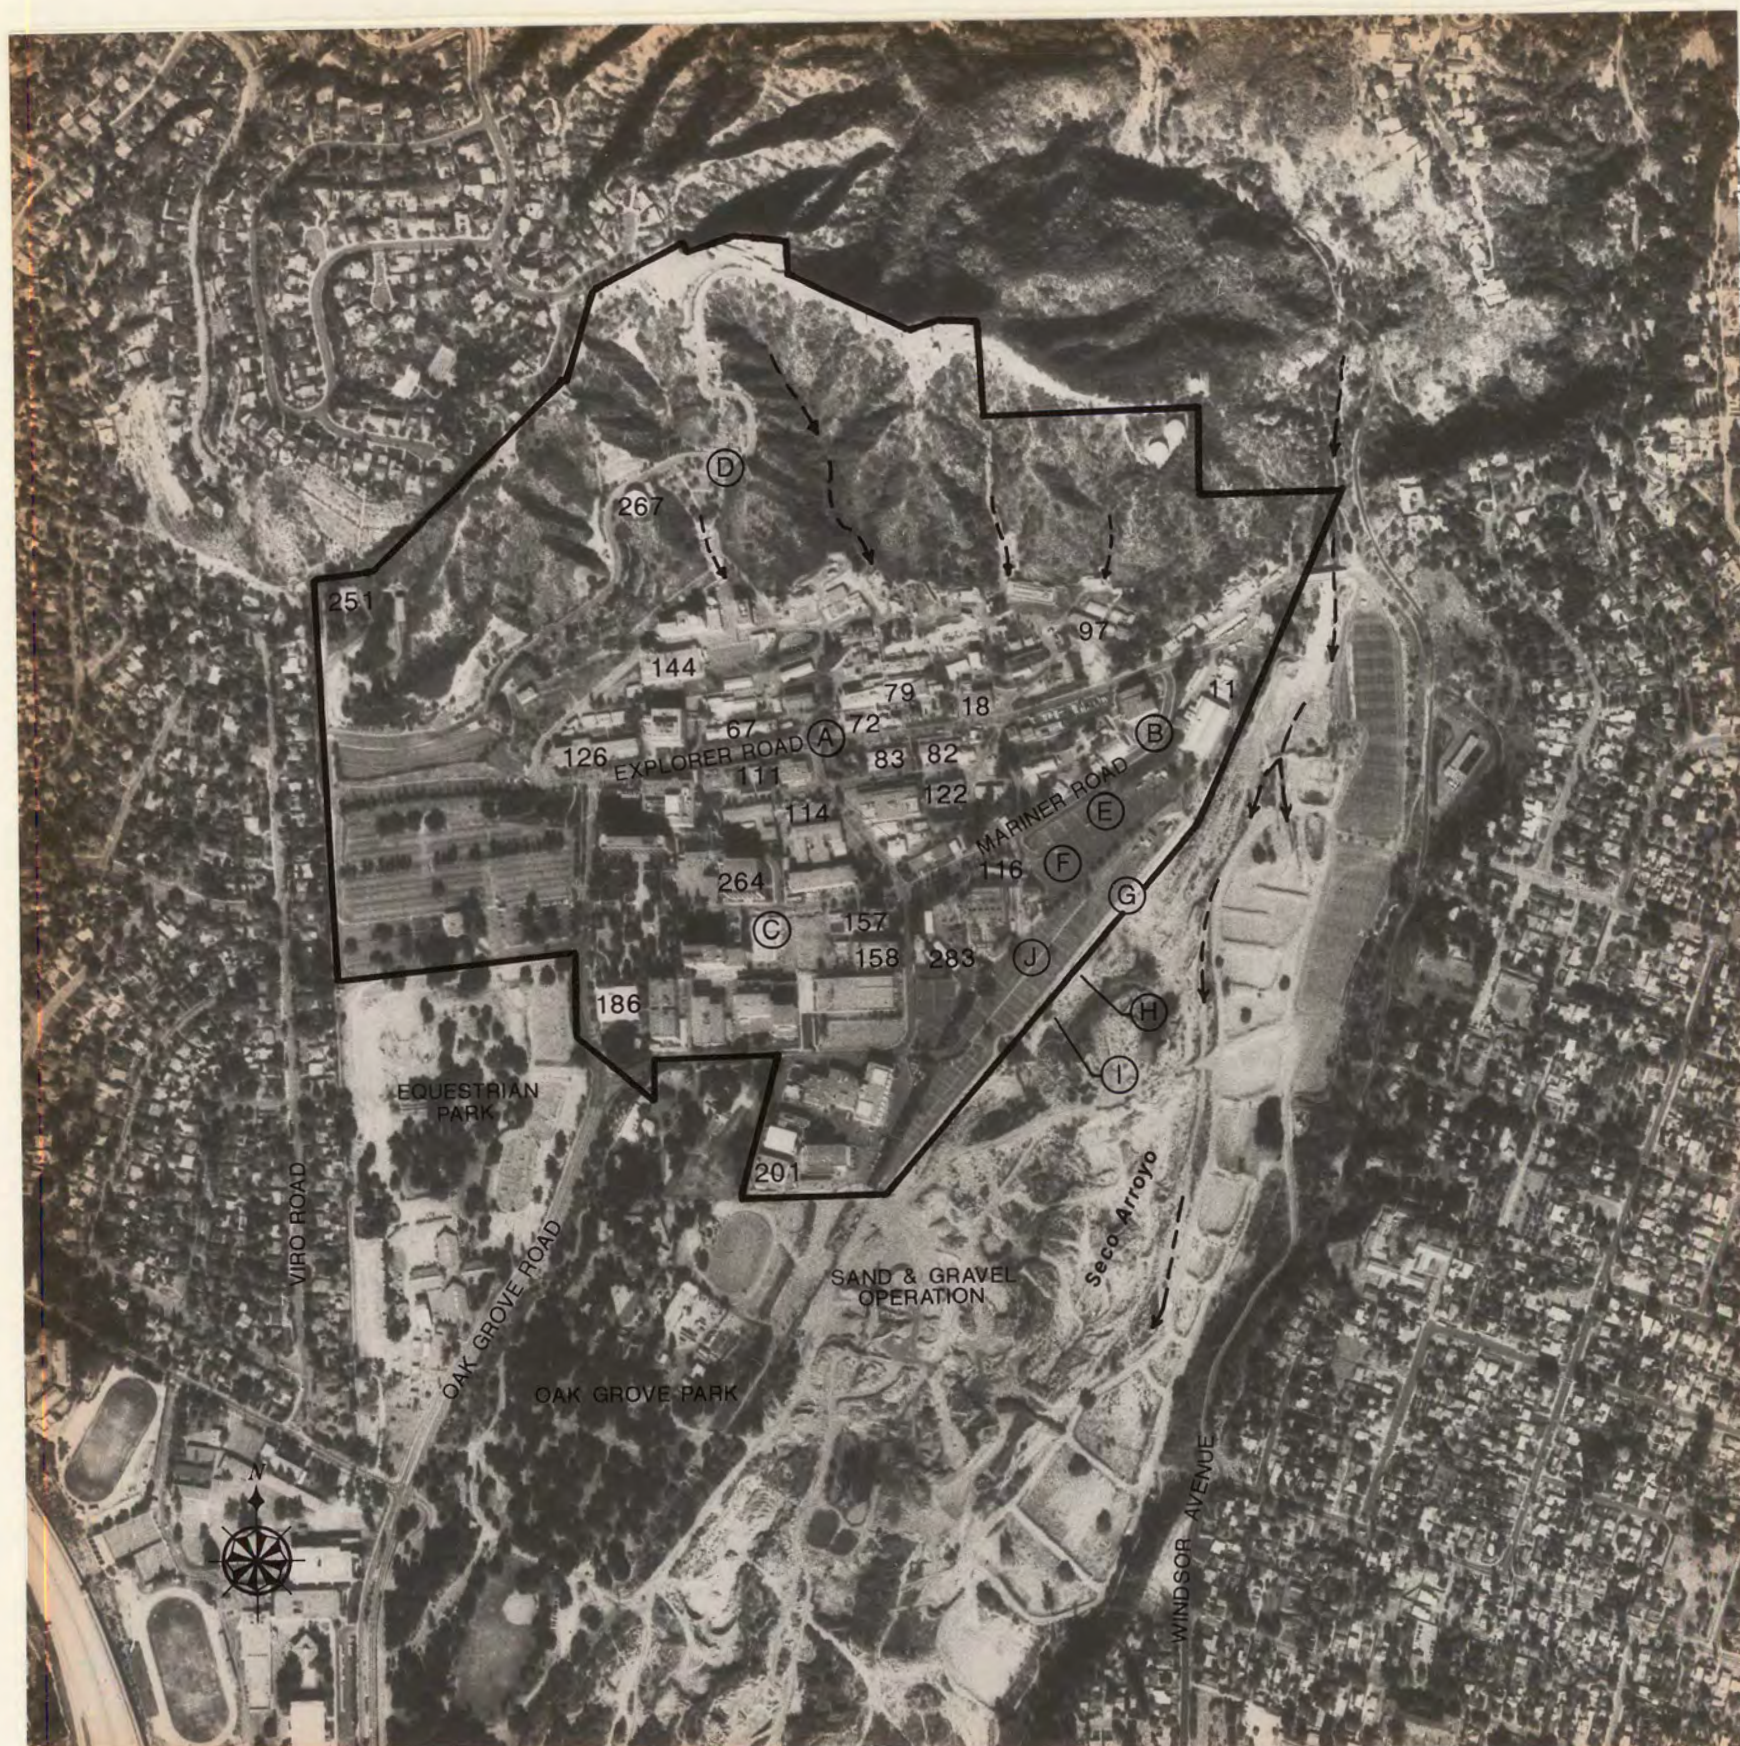
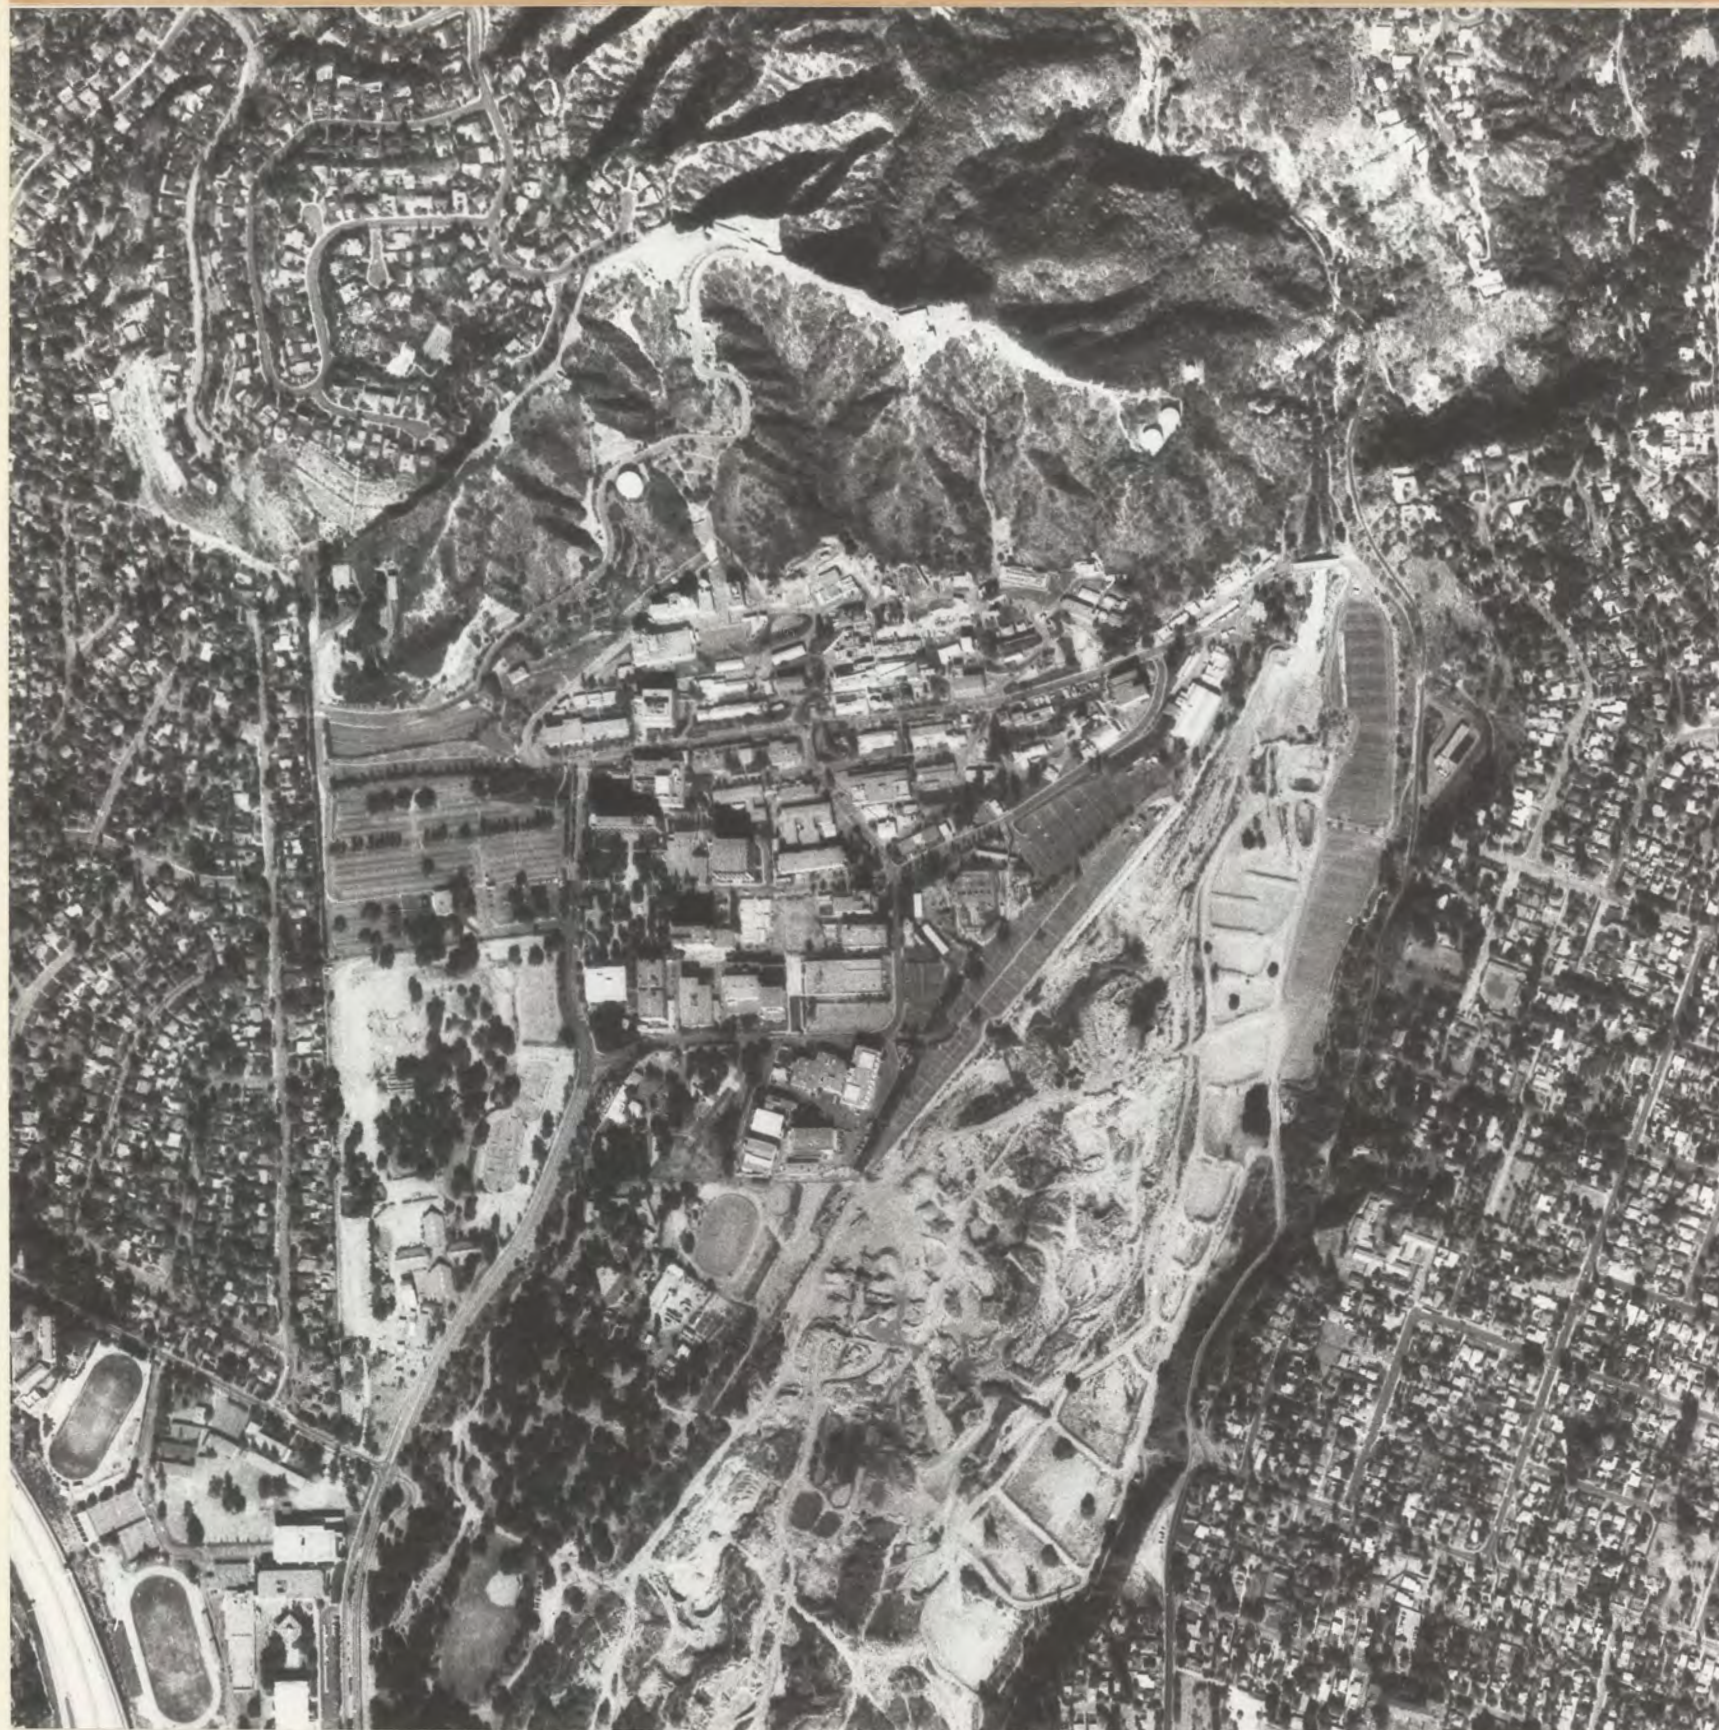
Figure 10. NASA Jet Propulsion Laboratory, November 25, 1977.  
Approximate scale 1:8,300.

The locations of previously reported features and those previously annotated JPL buildings are annotated as reference locations (Annotations A through J). The shape and size of several of these buildings have been modified and/or demolished to make space for ongoing construction. The location of the previously reported pool/tank is absent (Annotations E). This area is now a large parking lot. No operating waste disposal units are observed.

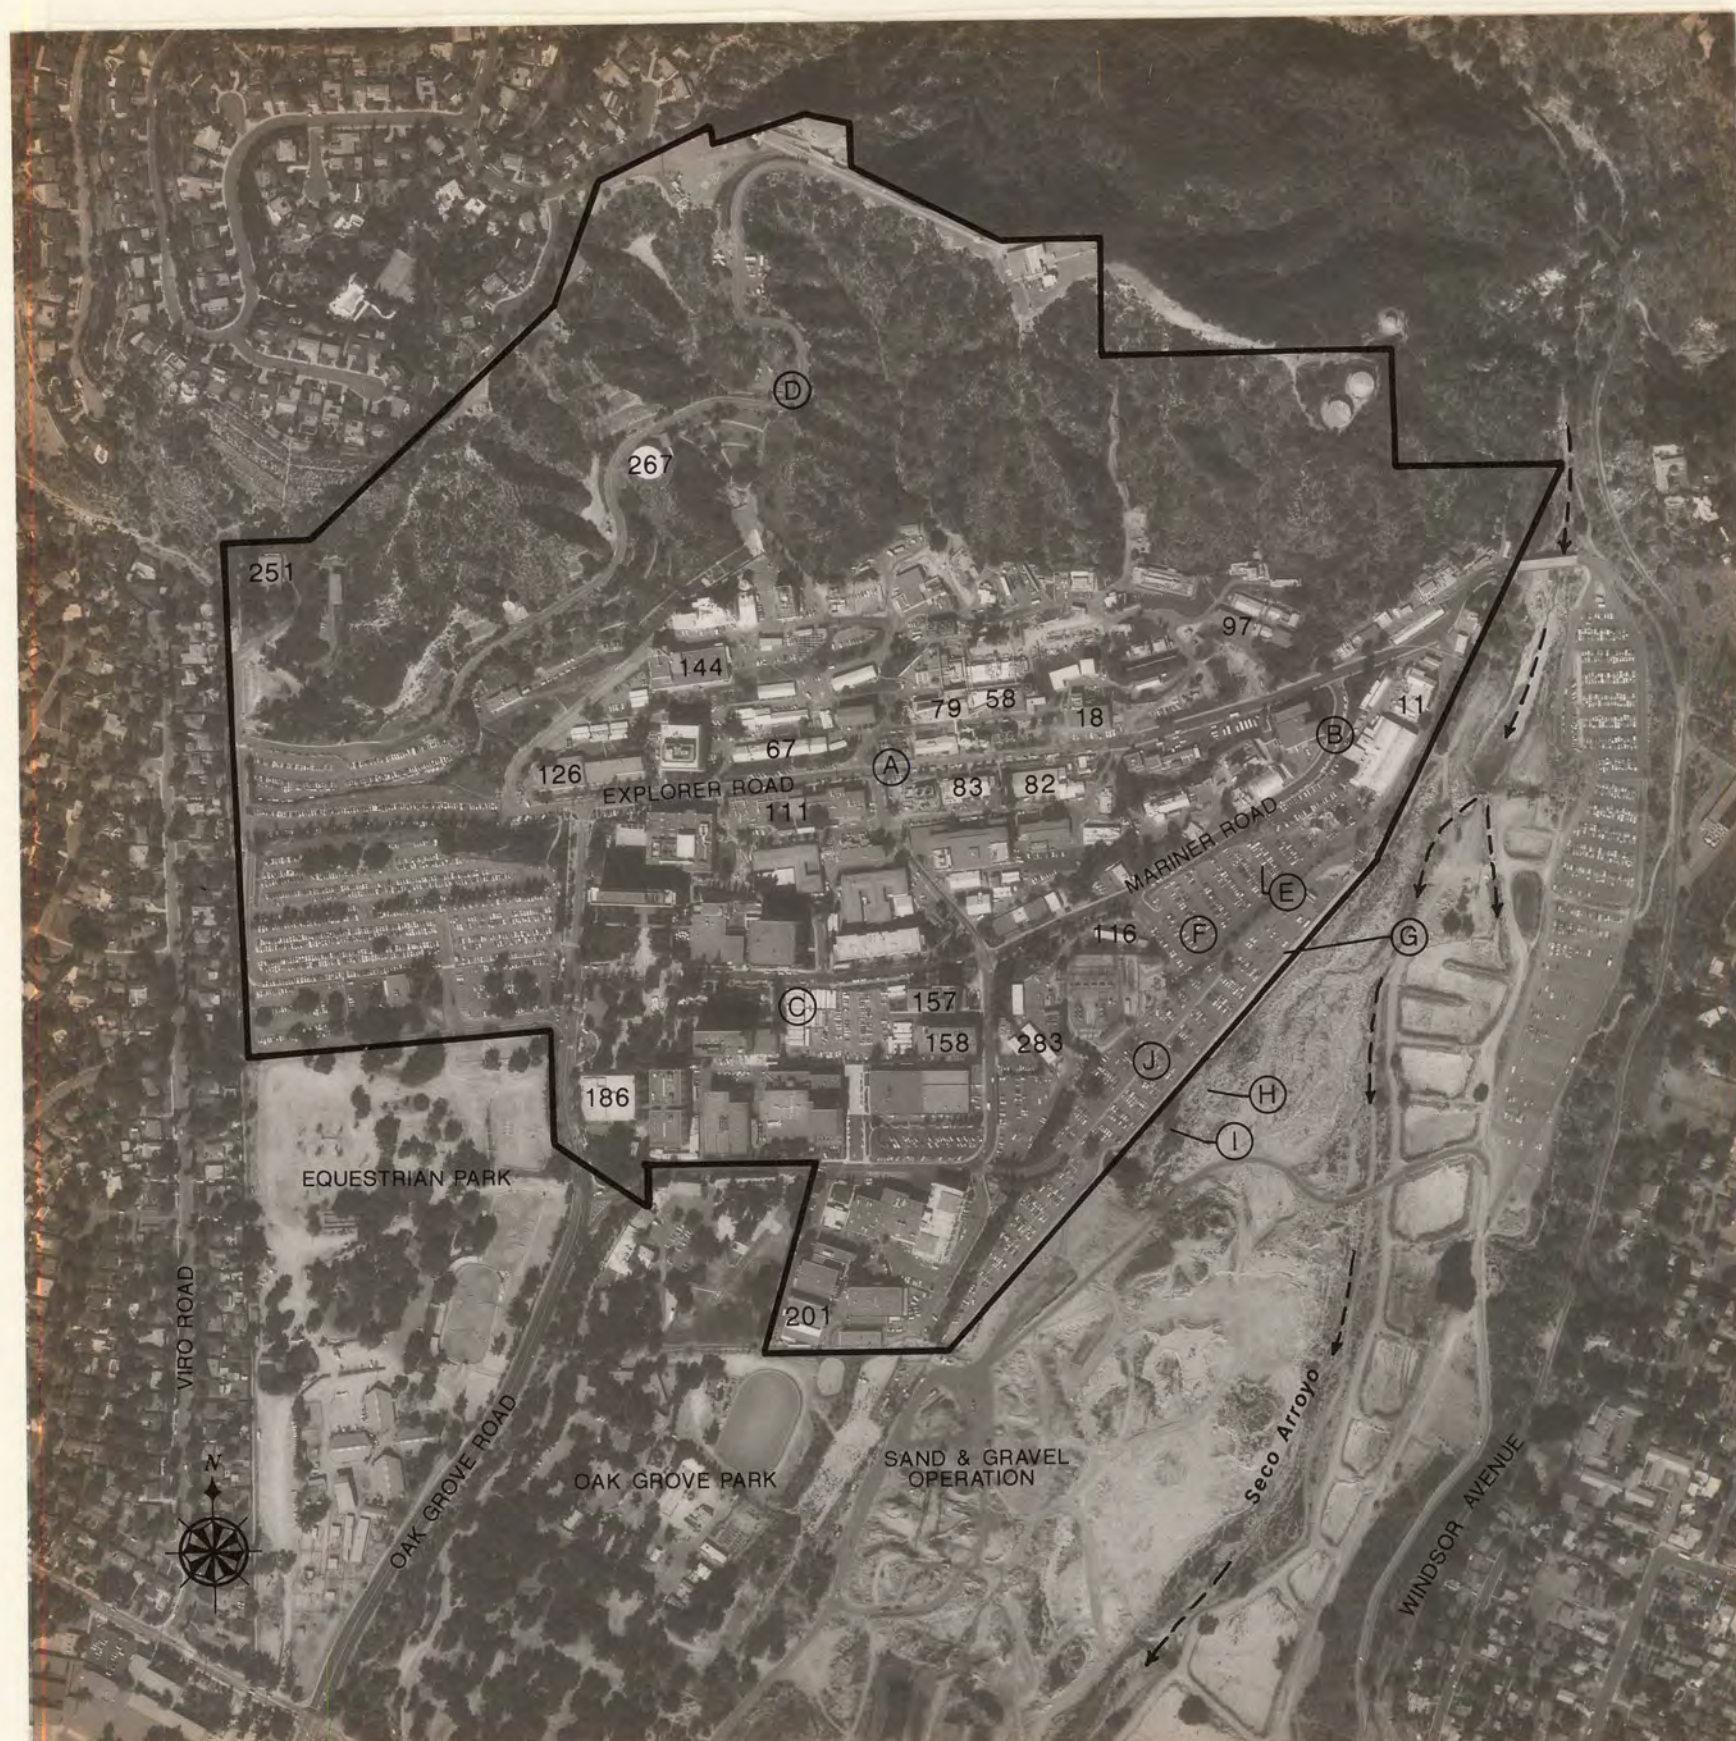
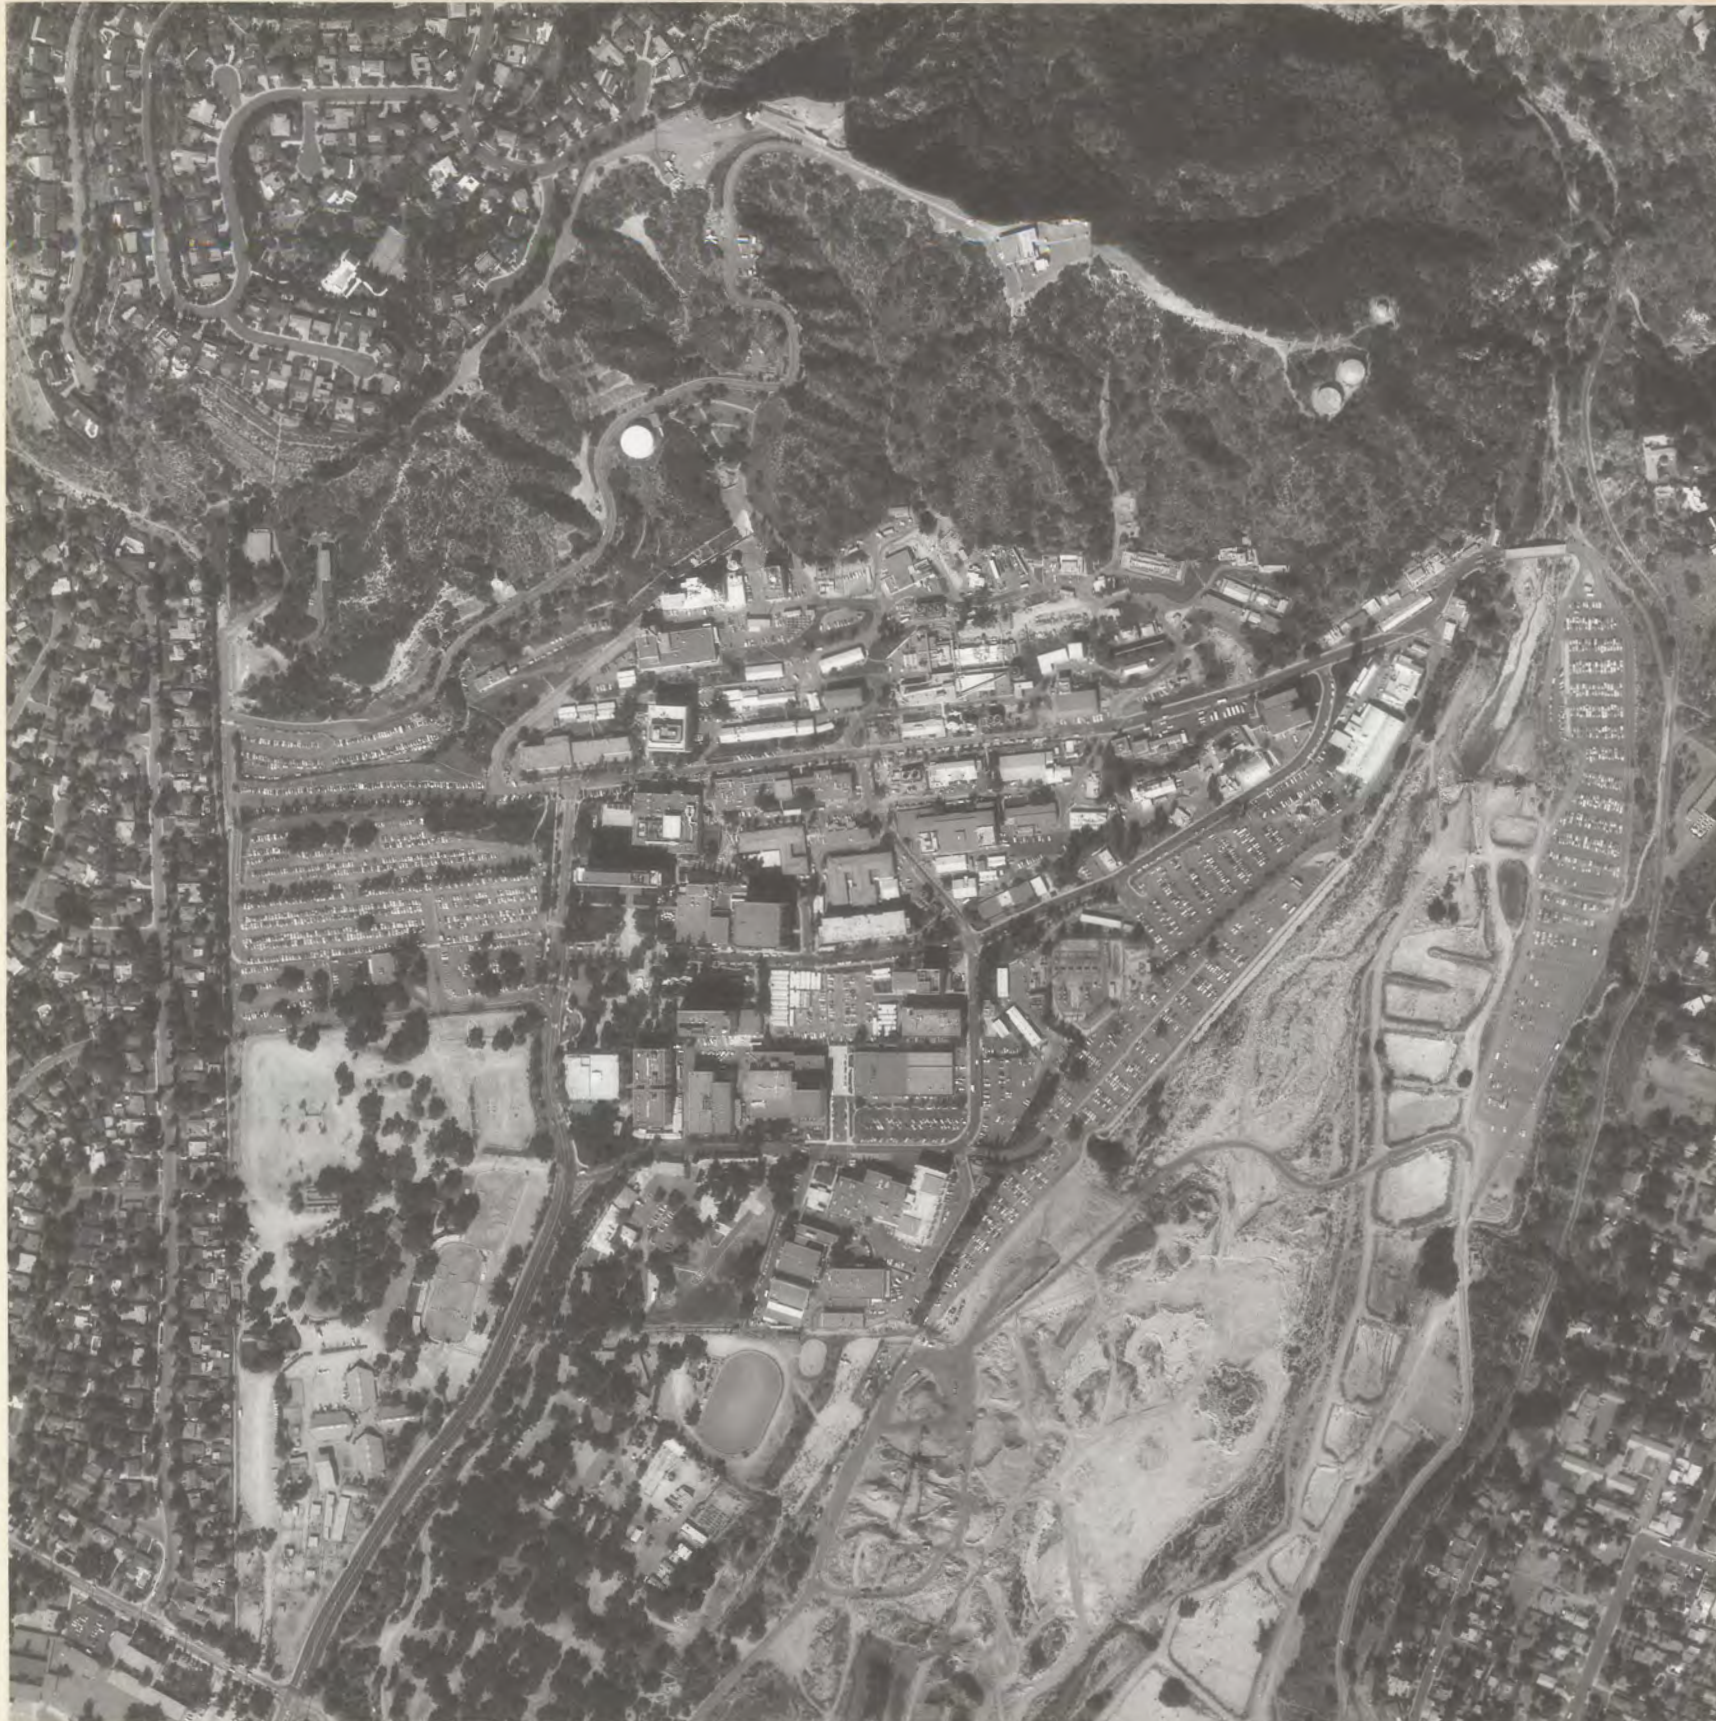
Figure 11. NASA Jet Propulsion Laboratory, October 21, 1980.  
Approximate scale 1:6,300.

The locations of previously reported features and those previously annotated JPL buildings are annotated as reference points "A" through "J". The 1980 photograph does not reveal significant construction at the JPL facility since 1977.

The suspected waste handling/disposal structures previously reported are no longer observed (Annotations E through I); parking lots now occupy most of these areas (Annotation J). No operating waste disposal units are observed.

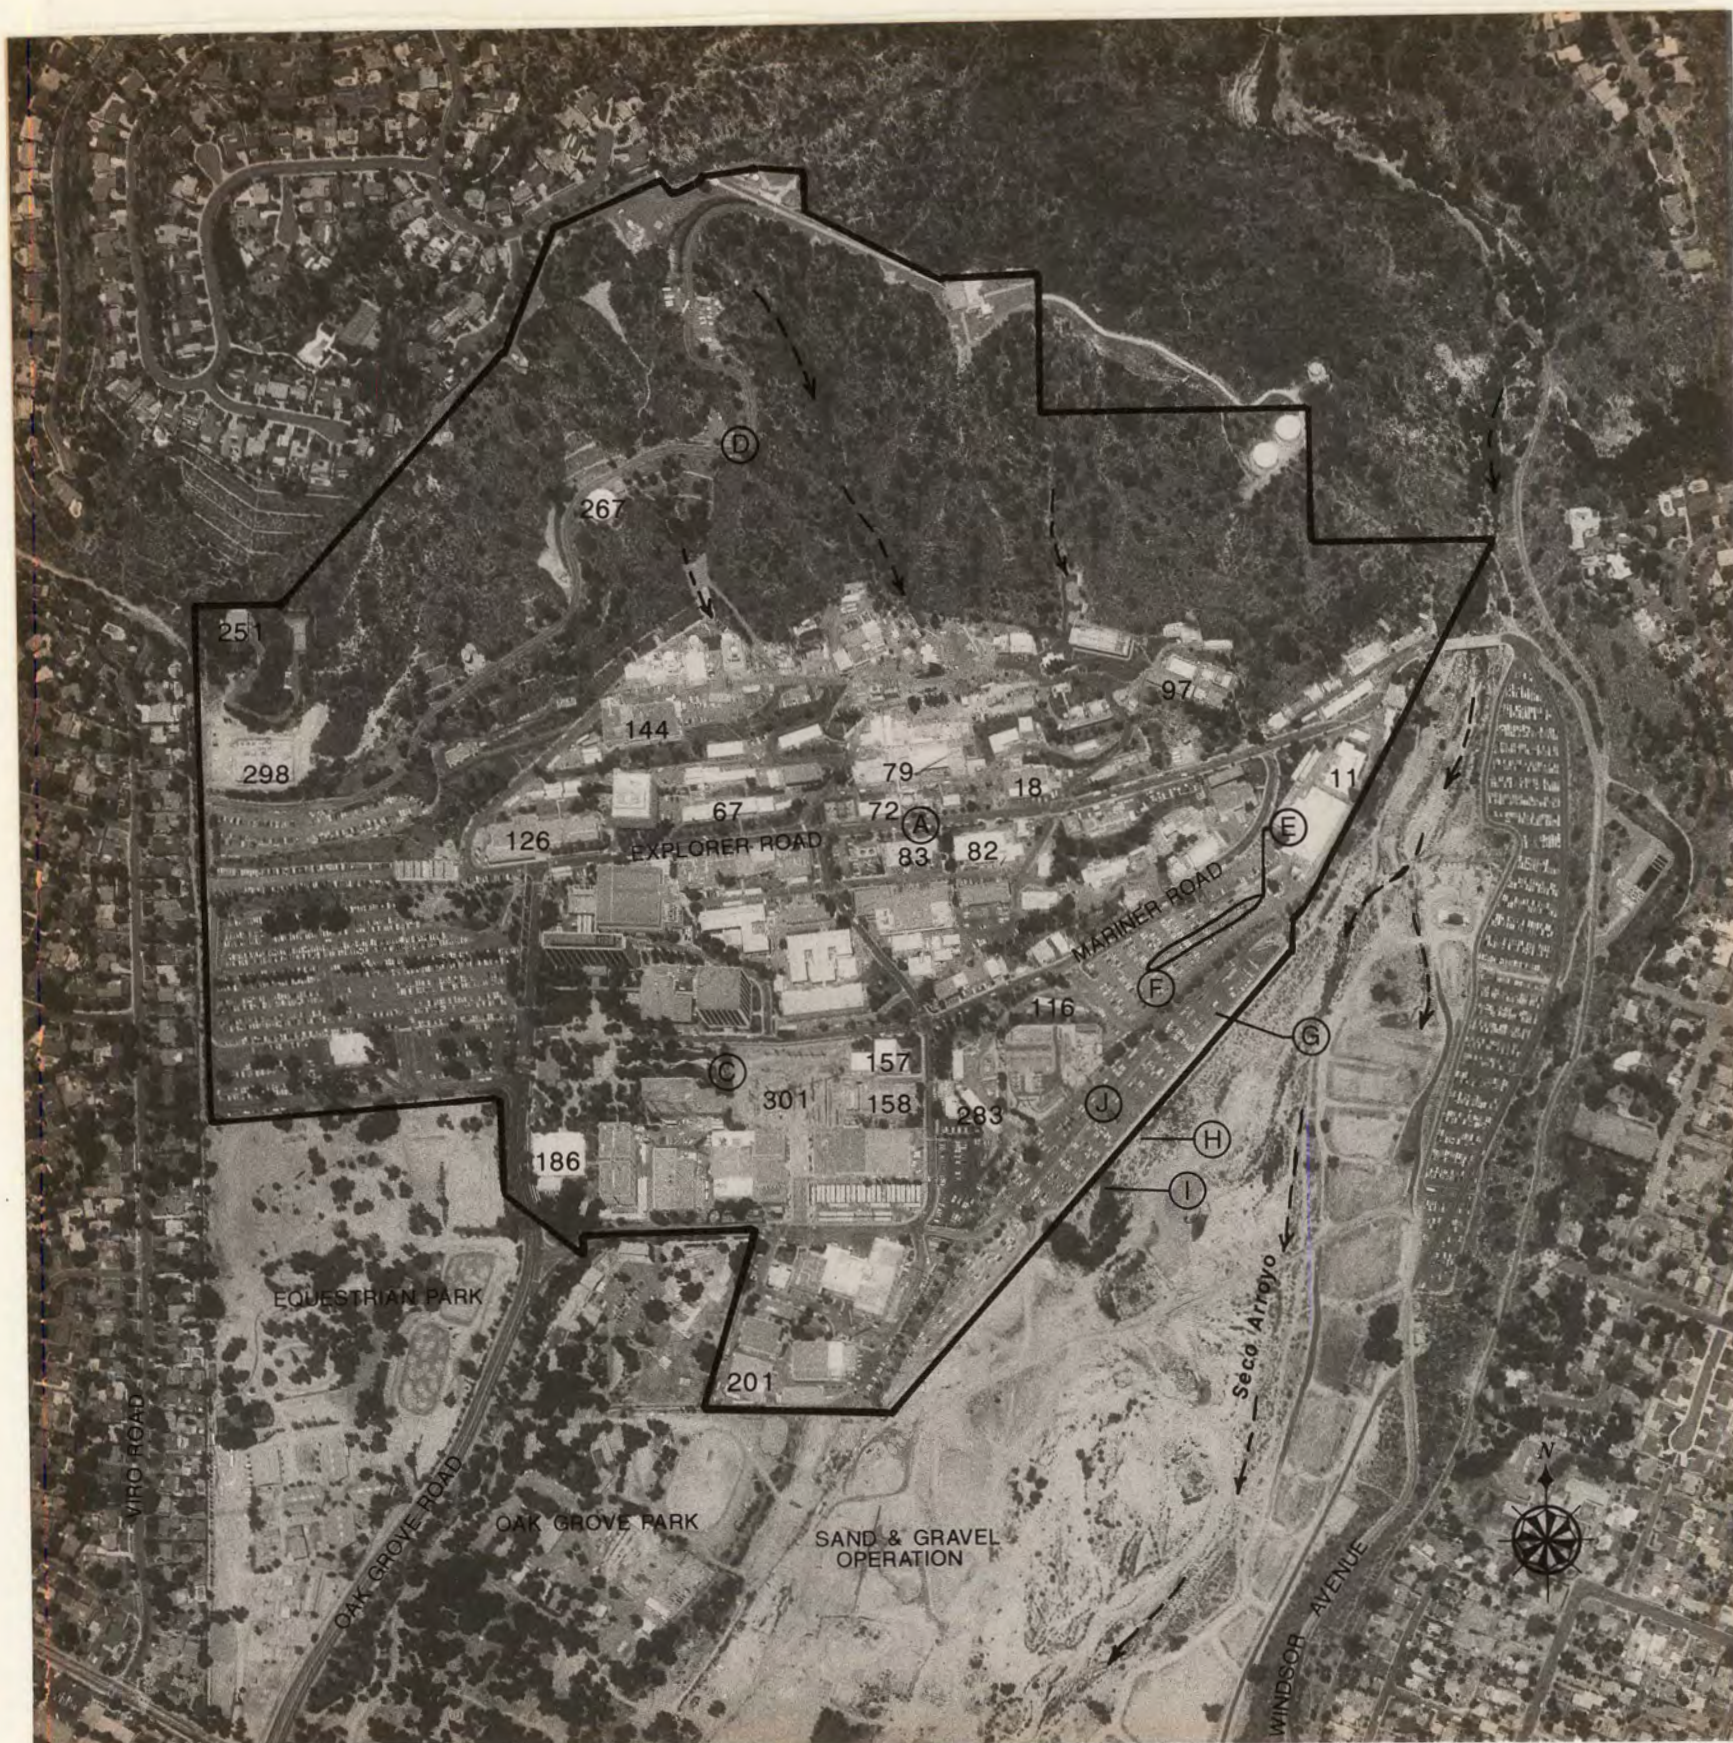
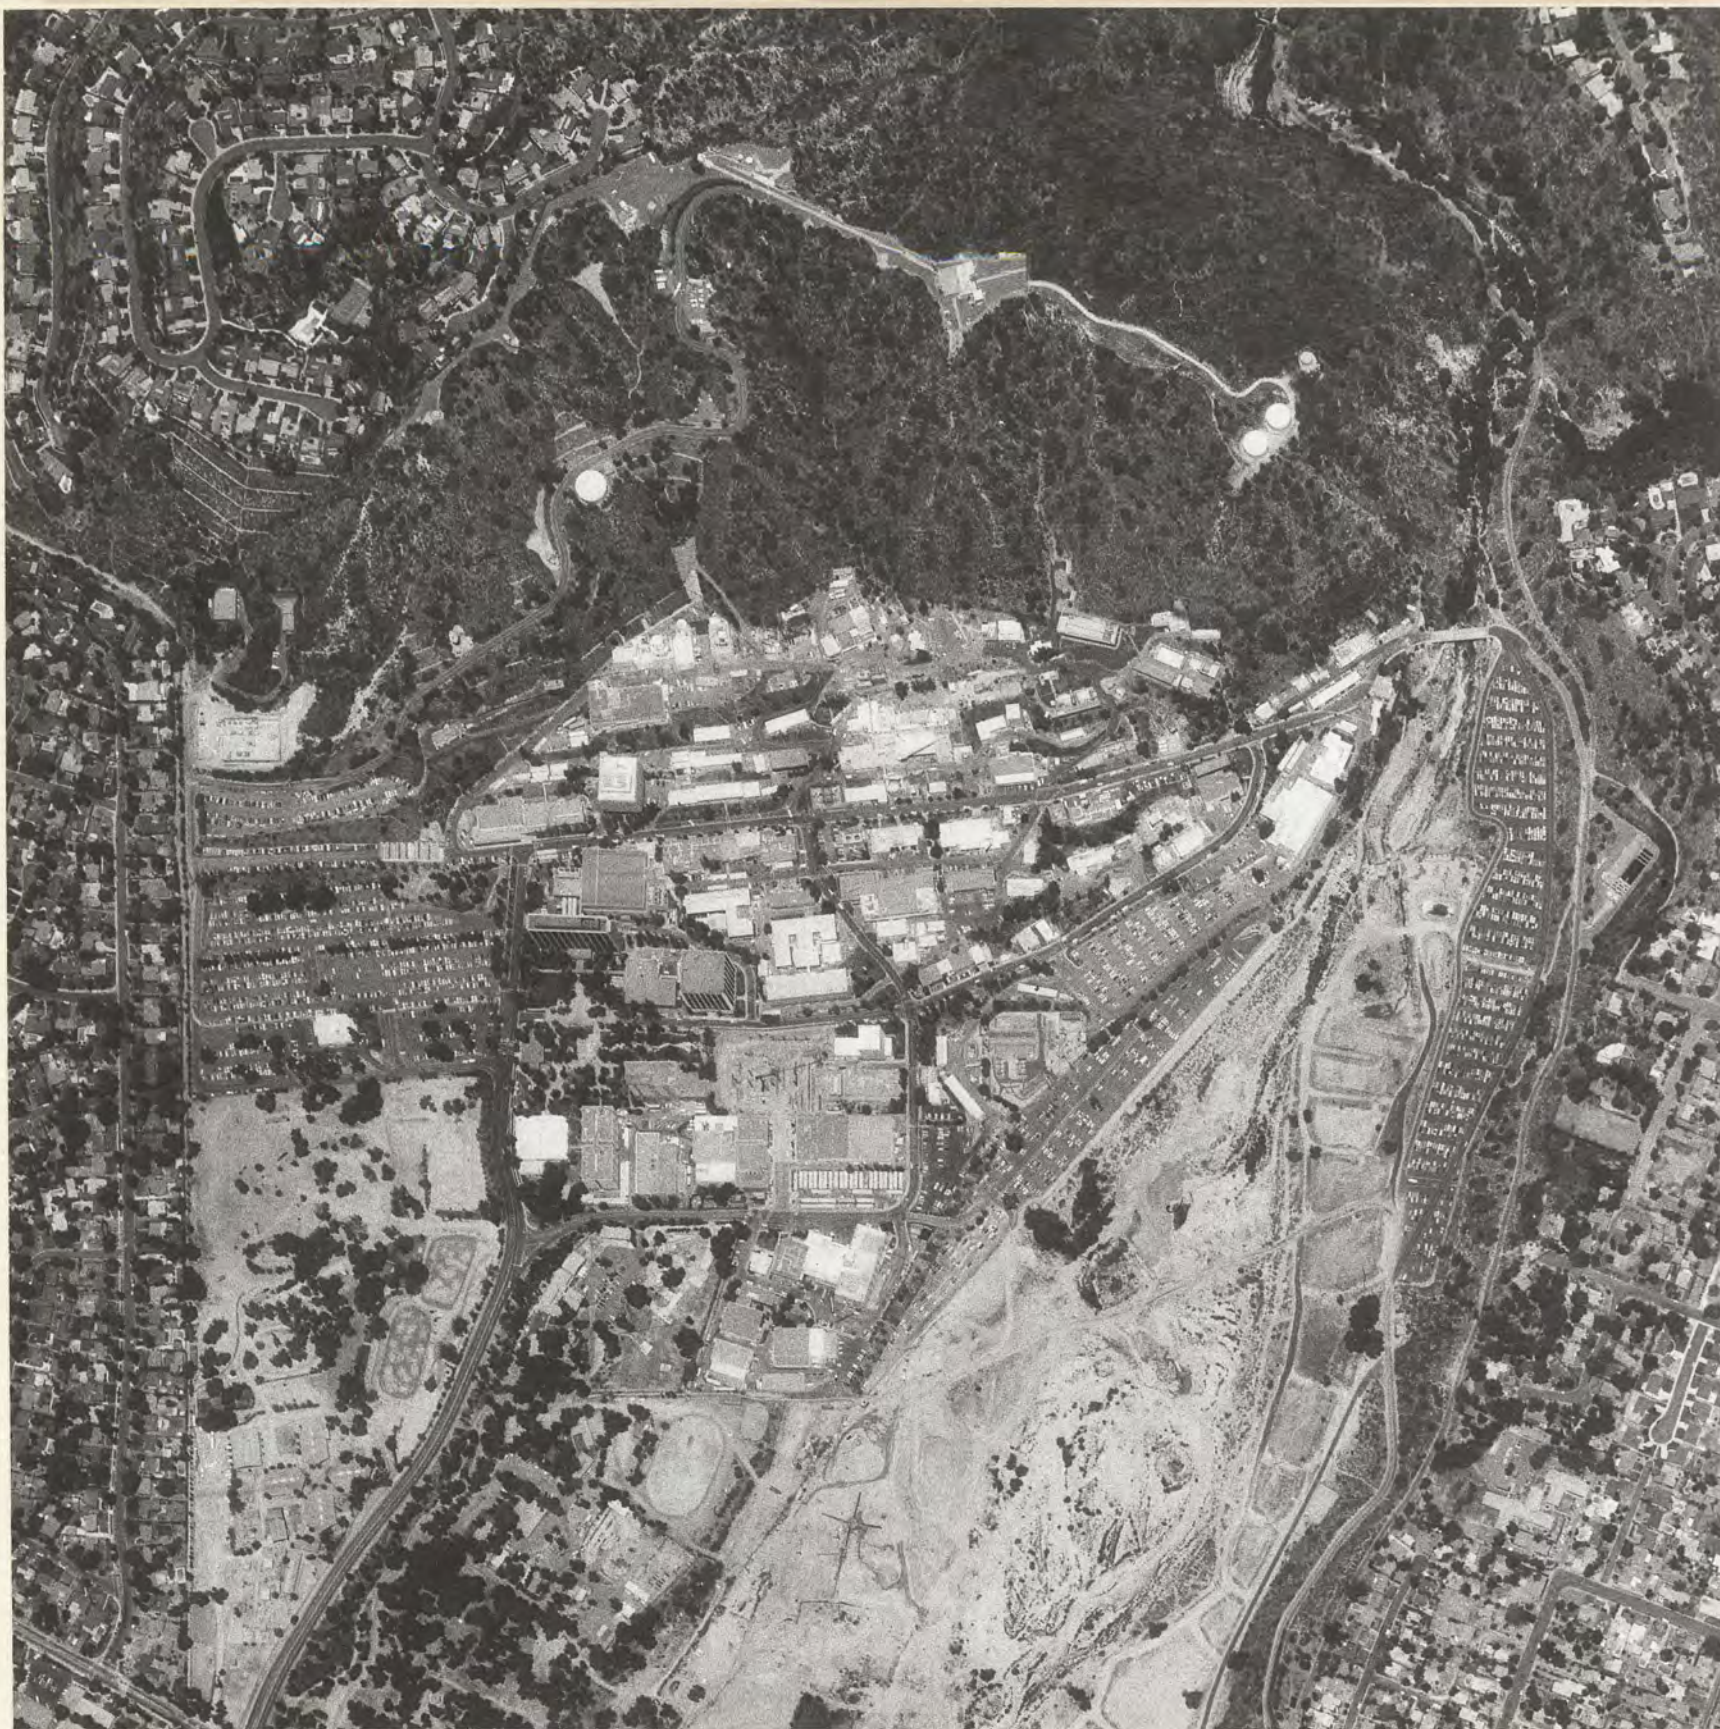
Figure 12. NASA Jet Propulsion Laboratory, July 3, 1985.  
Approximate scale 1:6,680.

The locations of previously reported features and those previously annotated JPL buildings are annotated as reference locations (Annotations A through J). The shape and size of several of these buildings have been modified and/or demolished to make space for ongoing construction. The 1985 photograph reveals continued construction has occurred at the JPL study site since 1980 with two building construction sites (Annotations 298 and 301). No operating waste disposal units are observed.
